**DHE-TSANG MONASTERY:  
PROTECTOR TEMPLE ARCHITECTURAL REPORT  
AUGUST '02**

**KHAM AID FOUNDATION  
ART AND ARCHITECTURAL CONSERVATION PROGRAM**

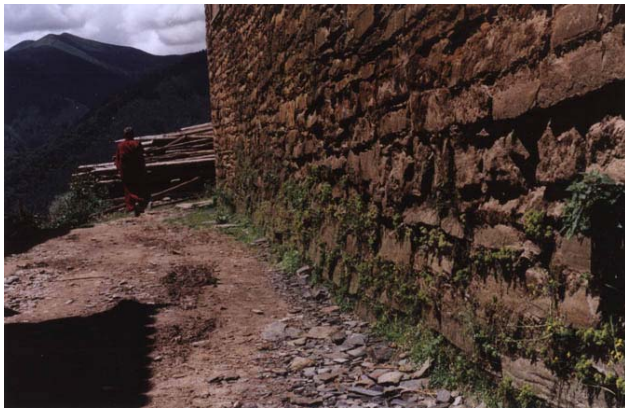
*South exterior wall of the Protector Temple with extensive plant growth at the base, evidence of excess moisture in the building fabric. The roof of the nearby kitchen (note shadow) and the roof of the Protector Temple shed large amounts of water into this narrow alley during downpours. Lack of adequate drainage results in moisture creeping up the walls of the building through capillary rise.*

not catch and lead away the water from the north of the building, where water from the north runs into the base of the structure. Adequate drainage is also required at the south wall, where there is insufficient clearance between the temple and the neighbouring kitchen. In addition, the kitchen roof overhang directs water to the south wall of the temple, and has led to widespread mortar loss and substantial biological growth, i.e. mosses, lichens, and other vegetation.

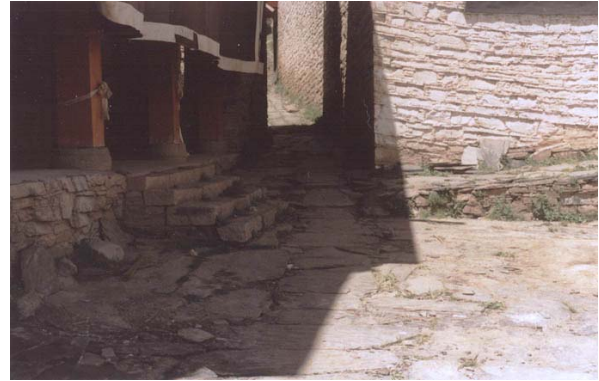
*Drainage running in front of the Protector Temple consists of a trench covered with slate. While this does lead water away from the east side of the building, it does not catch the water running into the north wall.*

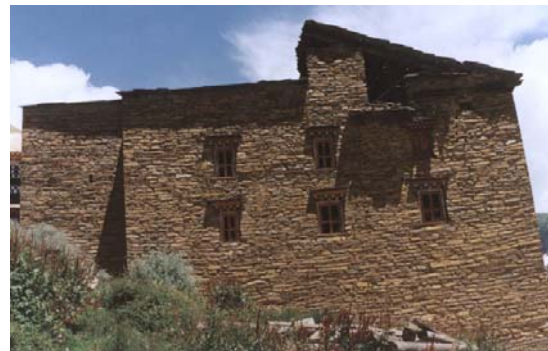
*Exterior west façade of Protector Temple with replacement windows that are paneless and unglazed. The lean of the south wall is visible from this perspective.*

The windows are constructed of unfinished wood and those on the upper floors are not glazed. Rain, snow, and other precipitation enter the building through faulty and/or paneless windows, causing deterioration of the wall plaster surfaces below the unglazed openings. A number of windows have been replaced, attesting to the failure of earlier models. Further mechanical damage is often evident at the openings where new windows of been installed, including the plastering over of wall paintings and poor masonry touch-up work.

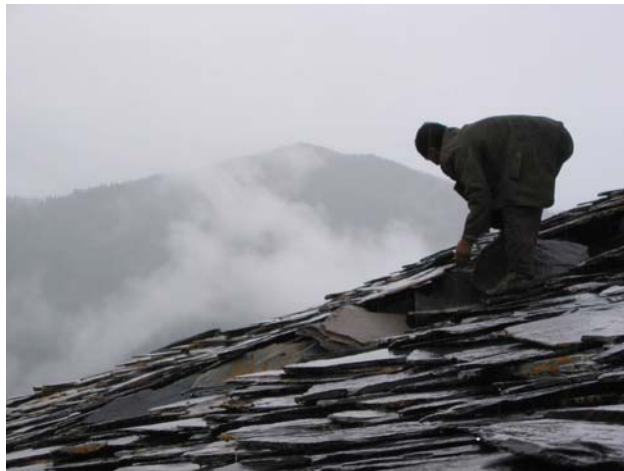
The roof undergoes routine maintenance to ensure the secure and proper placement of the slate. Nonetheless, frequent failure of the roof to adequately shed all precipitation is frequently seen during episodes of rain. Given that the attic flooring is itself incapable of shedding water, moisture easily makes its way into the fabric of the building. It should be noted that grain and other materials stored in the attic space themselves absorb the water and, during particularly heavy downpours, can become soaked substantially adding to the load of the roof, perhaps even contributing to the signs of overloading noticed in the structure.

*Repositioning of slate during rainstorm*
