**DHE-TSANG MONASTERY:  
PROTECTOR TEMPLE ARCHITECTURAL REPORT  
AUGUST '02**

**KHAM AID FOUNDATION  
ART AND ARCHITECTURAL CONSERVATION PROGRAM**

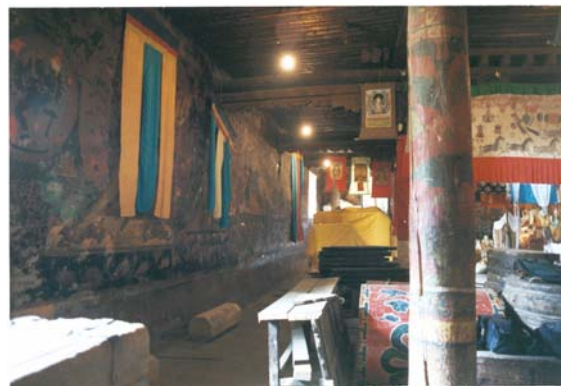
*View of interior south wall and painted column and crossbeams.*

on the second and third floors have been replaced, probably due to water damage, evident throughout the ceiling joists. These structural members on the upper floors are neither carved nor painted.

The building shows structural deficiencies, in terms of both design and material failure. Due to the incremental growth of the temple, it is assumed that construction campaigns were not co-ordinated, resulting in unsuitably located columns, beams, and wall openings.
